**DEPARTMENT OF TRANSPORTATION****DIVISION OF ENGINEERING SERVICES**

Contract #: 04-0120F4Cty: SF/ALA Rte: 80 PM: 13.2/13.9File #: 78.28**WELDING INSPECTION REPORT****Resident Engineer:** Casey, William**Address:** 333 Burma Road**City:** Oakland, CA 94607**Report No:** WIR-029999**Date Inspected:** 12-Sep-2013**Project Name:** SAS Superstructure**OSM Arrival Time:** 600**Prime Contractor:** American Bridge/Fluor Enterprises, a JV**OSM Departure Time:** 1600**Contractor:** Steward Machine Co.**Location:** Birmingham, AL**CWI Name:** Fred Hudson & Jimmy Brewer**CWI Present:** Yes No**Inspected CWI report:** Yes No N/A**Rod Oven in Use:** Yes No N/A**Electrode to specification:** Yes No N/A**Weld Procedures Followed:** Yes No N/A**Qualified Welders:** Yes No N/A**Verified Joint Fit-up:** Yes No N/A**Approved Drawings:** Yes No N/A**Approved WPS:** Yes No N/A**Delayed / Cancelled:** Yes No N/A**Bridge No:** 34-0006**Component:** E2 Shear Key Anchorages**Summary of Items Observed:**

## WELDING INSPECTION REPORT

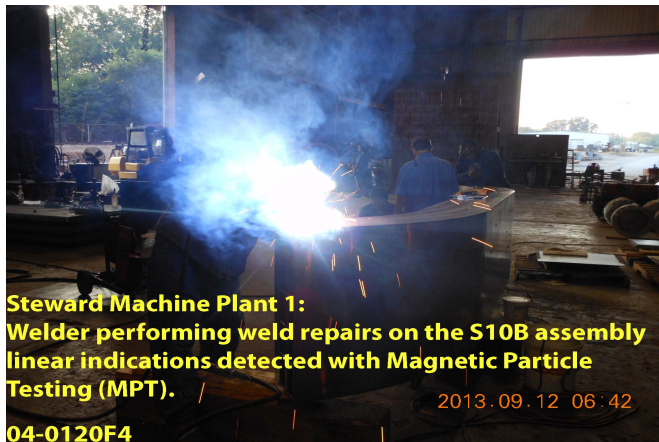
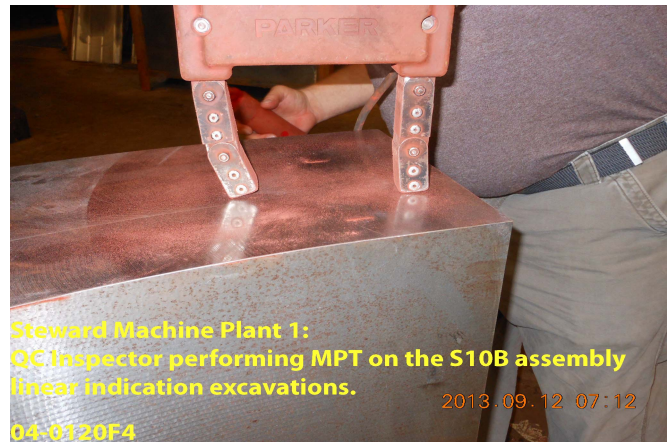
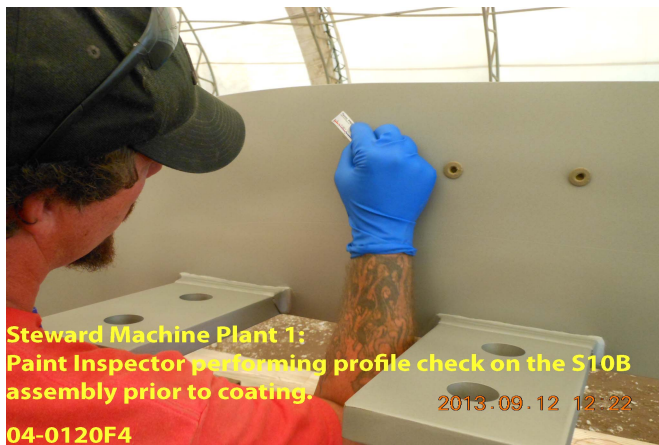
S10B Assembly Magnetic Particle Testing (MPT) Weld Repair:

- Two (2) Indication Excavations (MPT Acceptable. See TL-6028 for detailed information).
- o MPT of repairs requires 48hr hold prior to final MPT. (Courtesy MPT performed irrelevant)
